Technical Bulletin

Model
911C4

Subject: Camshaft Housing Cover
Reinforcement

Number
9007

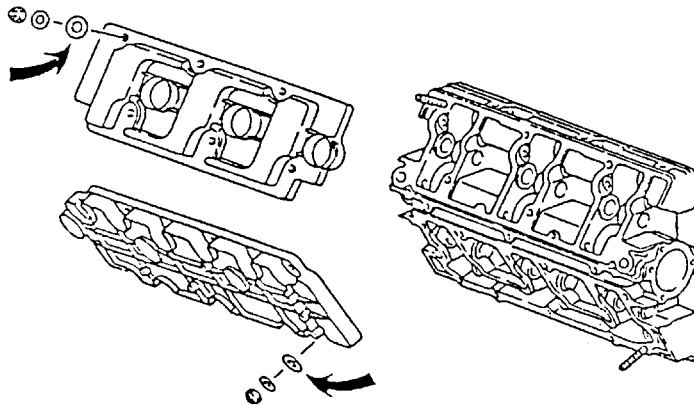
Concern: Camshaft housing covers (upper and lower) without reinforcement in the area of the mounting stud holes were installed in production from engine number 62K00149 through 62K00399.

Service Information: An additional aluminum washer (arrows in figure) is installed on each cover mounting stud. The washers **must** be reinstalled when working on these covers to prevent oil leaks. Washers, Part Number PNA 025 193 30, can be ordered from the Parts Department. Do not substitute any other washer. If a cam cover needs to be replaced, only the new reinforced version will be available.

Tightening torque camshaft housing cover to camshaft housing — 9.7Nm (7 ft. lb.).
