Technical Bulletin

Subject: Disc Jammed in CD Changer
(CDC-1)

Number
9305

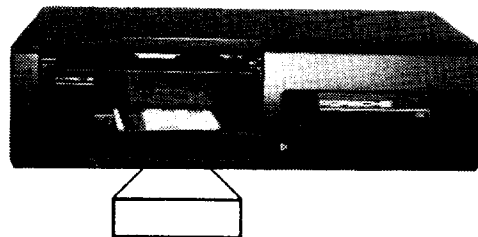
Figure 1

If the CDC-1 is not operational for any reason, one of four error codes may appear in the display of the CR-1 radio (see Figure 1).

INDICATION	CAUSE
E01	Disc-change malfunction
	Disc-change malfunction
	Magazine ejection impossible
E02	Disc is in player mechanism
--H	High Temperature
EEE	Misconnection or disconnection of CD CHANGER

If E01 or E02 appears, proceed as follows:

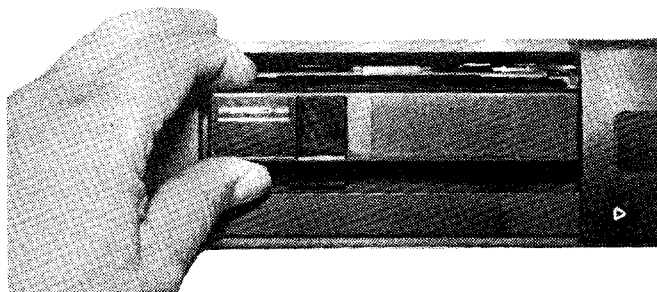
Figure 3a

2. Remove the magazine and remove any compact discs in the magazine. Check the magazine for distortion or damage. Replace if necessary (see Figures 3a and 3b).
