Technical Bulletin

Model
911C2/911C4

Subject: Engine, Inconsistent Performance

Number
9005

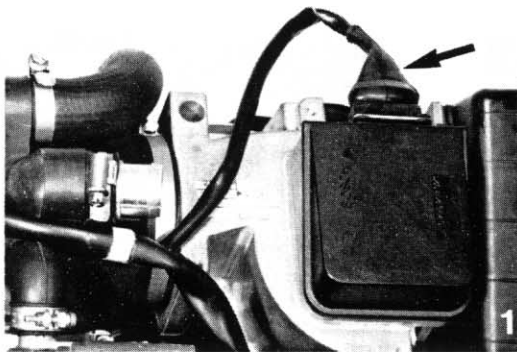
Figure 1

Possible Cause: The air flow meter wiring harness protective cover (Figure 1) contacts the engine ventilation hoses (Figure 2) causing current flow interruptions on the plug terminals.

Repair Information: 911 Carrera 2 model year 1990 and 911 Carrera 4 model years 1989 and 1990 prior to the above VIN's should be modified when the engine is removed or when working on the air flow meter, even if no engine performance problems are present.
