Technical Bulletin

Subject: **Noise from Power Steering Hydraulic System**

Number
9402

Models Affected: *911 Carrera 2/4/Turbo, up to 1994*

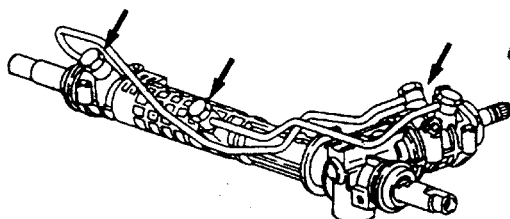
Figure 1

Piston valve steering gear

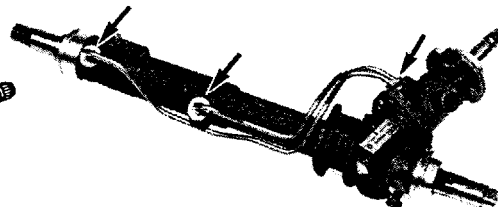
Figure 2

Rotary valve steering gear

Arrows = distinctive feature (pipe connections)
