Technical Bulletin

Model
911C2/C4

Subject: Radio Interference from Alternator

Number
9101

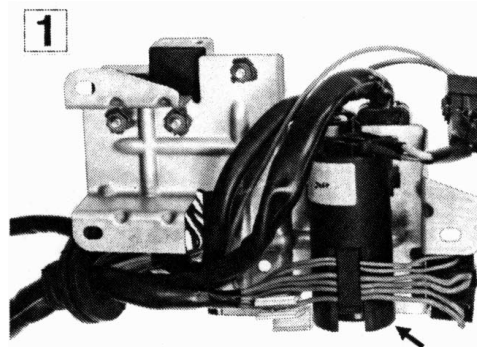
Figure 1

Concern: Radio interference (whistling) from alternator.

Repair Information: An interference suppression filter may be installed on the engine compartment fuse/relay board to alleviate this condition (arrow, Figure 1).
